Manhole Inspection Summary

Manhole # S09OO_017MH

Insp Date: **8/9/07 11:43 AM**

Location Address: **2618 HILTON ST**

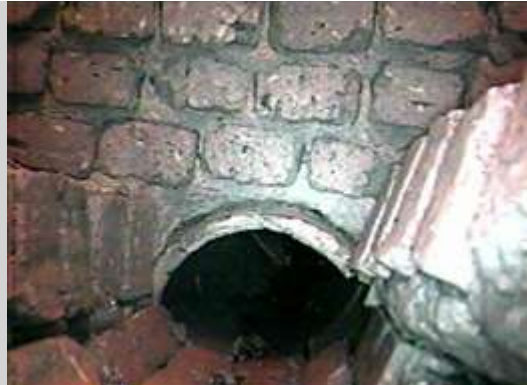
12 O'Clock Outflow

8 in. Circular Gravity Sewer
Pipe Out @ 12 O'Clock

Pipe Height: (in.) Direct
Pipe Material: **Clay** ☐ Pipe Lined
Invert Depth: **4.40** (ft.) Flow Characteristics: **Slow**
Deposits: ☒ None ☐ Mud ☐ Sludge ☐ Debris ☐ Grease
Silt Depth: (in.) Deposits Extent:
Infiltration: **None** Pipe Seal Cond: **Cracked**

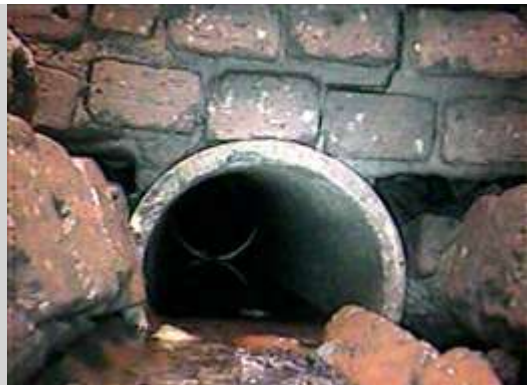
5 O'Clock Inflow

8 in. Circular Gravity Sewer
Pipe In @ 5 O'Clock

Pipe Height: (in.) Direct
Pipe Material: **Clay** ☐ Pipe Lined
Invert Depth: **3.95** (ft.) Flow Characteristics: **Slow**
Deposits: ☒ None ☐ Mud ☐ Sludge ☐ Debris ☐ Grease
Silt Depth: (in.) Deposits Extent:
Infiltration: **None** Pipe Seal Cond: **Broken**
